Army Lodging Wellness Recommendation

Fort Riley - Final Submittal

July 23, 2003

Section 1 Wellness Recommendation

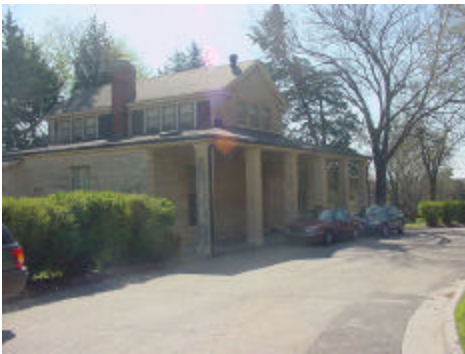
Building 28, Bacon Hall

Building 28, constructed in 1909, is an historical structure and is a single DVQ family suite. This facility has two stories, including the basement. The suite is approximately 1,770 square feet. The building is in fair condition but does not comply with Lodging requirements. The cost to make condition assessment improvements will exceed the 50% replacement cost.

Our recommendation is to remove building 28 from the Lodging inventory, allowing the installation to determine an alternate use for this facility. This facility will be removed from the Fort Riley Wellness Solution and Lodging Master Plan.

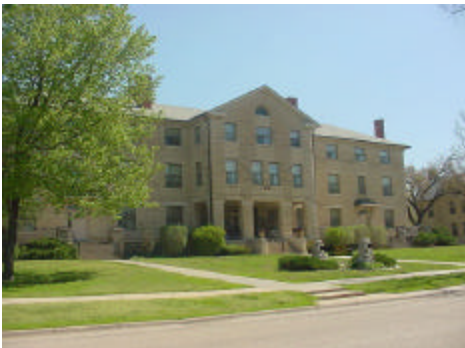
Building 45, Carr Hall

Building 45, constructed in 1904, is an historical structure and is divided into 11 family suites. This facility has three stories plus a basement. Each suite is 545 square feet, consisting of a living room, bedroom, and full bath. In addition to the family suites, this facility houses 7 open office spaces, 20 private offices, and 2 conference rooms. This facility had the HVAC system replaced in 1994. The building is in fair condition but does

not comply with Lodging requirements. The cost to make condition assessment improvements will exceed the 50% replacement cost.

Our recommendation is to remove building 45 from the Lodging inventory, allowing the installation to determine an alternate use for this facility. This facility will be removed from the Fort Riley Wellness Solution and Lodging Master Plan.

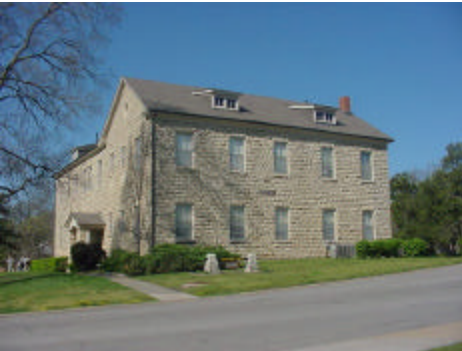
Building 170, Waters Hall

Building 170, constructed in 1888, is an historic structure that is divided into 8 family suites. This facility has two stories plus a basement. Each suite has 732 square feet, consisting of a living room, bedroom, and full bath. The building is in fair condition but does not comply with Lodging standards. The cost to make condition assessment improvements will exceed the 50% replacement cost.

Our recommendation is to remove building 170 from the Lodging inventory, allowing the installation to determine an alternate use for this facility. This facility will be removed from the Fort Riley Wellness Solution and Lodging Master Plan.

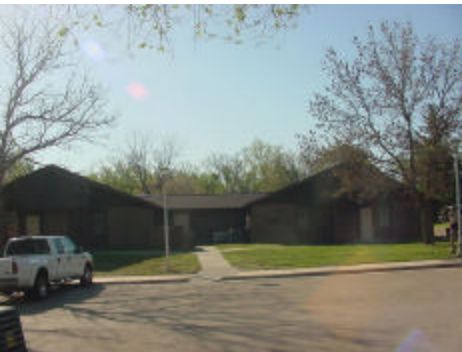
Building 470, constructed in 1972, has 5 family suites. The facility is one story with three 700 s.f. suites, and two 450 s.f. suites, consisting of a living room, bedroom, kitchen, and full bath. The building is in good condition, although it exceeds Lodging size standards. The cost to renovate to meet Army Lodging square footage standards will exceed 50% replacement cost.

Our recommendation is to remove building 470 from the Lodging inventory, allowing the installation to determine an alternate use for this facility. This facility will be removed from the Fort Riley Wellness Solution and Lodging Master Plan.

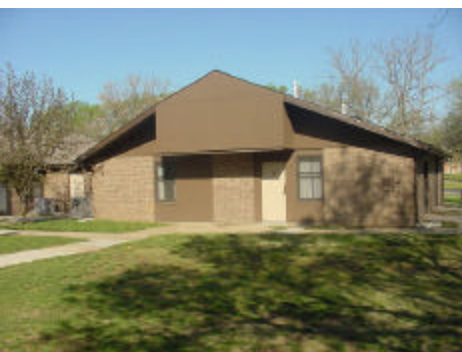
Building 471, constructed in 1972, has 4 family suites. The facility is one story with 700 s.f. suites consisting of a living room, bedroom, kitchen, and full bath. The building is in fair condition, although it exceeds Lodging size standards. The cost to renovate to meet Army Lodging square footage standards will exceed 50% replacement cost.

Our recommendation is to remove building 471 from the Lodging inventory, allowing the installation to determine an alternate use for this facility. This facility will be removed from the Fort Riley Wellness Solution and Lodging Master Plan.

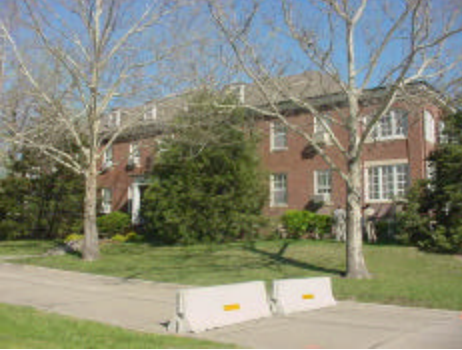
Building 510, Grimes Hall

Building 510, constructed in 1931, is an historic structure that is divided into 7 DVQ family suites. This facility has two stories plus a basement. Each suite has 433 square feet, consisting of a living room, bedroom, and full bath. The building is in fair condition but does not comply with Lodging standards. The cost to make improvements and bring it up to Army Lodging standards will exceed the 50% replacement cost.

Our recommendation is to remove building 510 from the Lodging inventory, allowing the installation to determine an alternate use for this facility. This facility will be removed from the Fort Riley Wellness Solution and Lodging Master Plan.

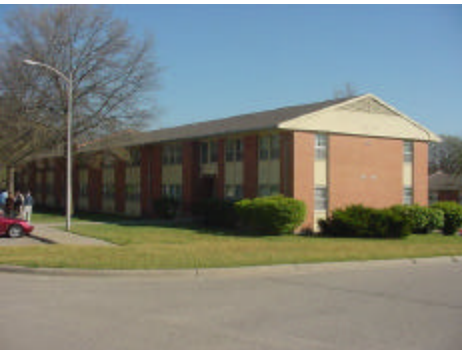
Building 541, Lott Hall

Building 541, constructed in 1966, has 6 family suites and 31 standard guest rooms. This facility has two stories, without a basement. Each family suite has 400 square feet, consisting of a living room, bedroom, kitchen, and full bath. Each standard room has 340 square feet. The existing plumbing and HVAC are in poor condition, and the rooms do not comply with Lodging standards. The cost to make improvements and bring the facility up to Army Lodging standards will exceed the 50% replacement cost.

Our recommendation is to remove building 541 from the Lodging inventory, allowing the installation to determine an alternate use for this facility. This facility will be removed from the Fort Riley Wellness Solution and Lodging Master Plan.

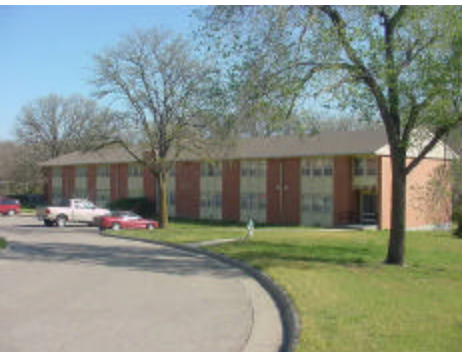
Building 542, Hoyle Hall

Building 542, constructed in 1966, has 30 standard guest rooms. This facility has two stories, without a basement. Each room has 340 square feet, consisting of a living room, bedroom, kitchen, and full bath. The building is in fair condition but does not comply with Lodging standards. The cost to make improvements and bring it up to Army Lodging standards will exceed the 50% replacement cost.

Our recommendation is to remove building 542 from the Lodging inventory, allowing the installation to determine an alternate use for this

facility. This facility will be removed from the Fort Riley Wellness Solution and Lodging master plan.

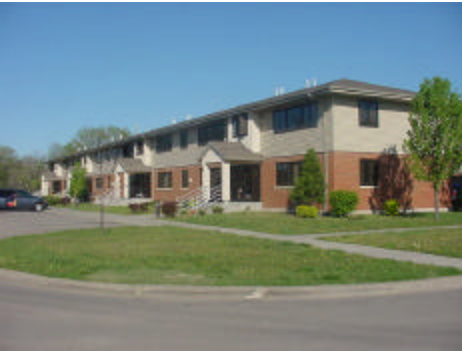
Building 620, constructed in 1960, has 12 family suites. This facility has two stories plus a basement. Each family suite has 776 square feet, consisting of a living room, bedroom, kitchen, and full bath. The building is in good condition but does not comply with Lodging standards. The cost to make improvements and bring it up to Army Lodging standards will exceed the 50% replacement cost.

Our recommendation is to remove building 620 from the Lodging inventory, allowing the installation to determine an alternate use for this facility. This facility will be removed from the Fort Riley Wellness Solution and Lodging Master Plan.

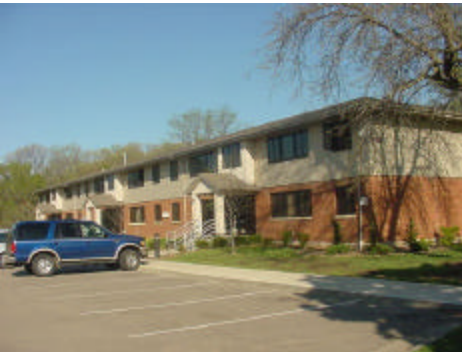
Building 621, Kimball Hall

Building 621, constructed in 1960, has 12 family suites. This facility has two stories plus a basement. Each family suite has 650 square feet, consisting of a living room, bedroom, kitchen, and full bath. The building is in good condition but does not comply with Lodging standards. The cost to make improvements and bring it up to Army Lodging standards will exceed the 50% replacement cost.

Our recommendation is to remove building 621 from the Lodging inventory, allowing the installation to determine an alternate use for this facility. This facility will be removed from the Fort Riley Wellness Solution and Lodging Master Plan.

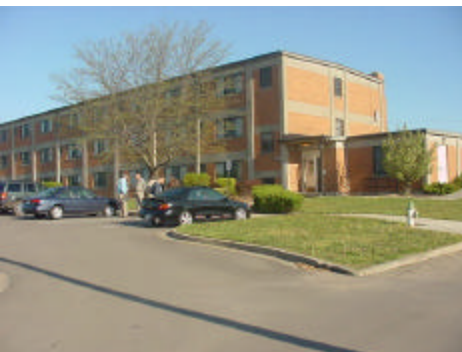
Building 5309, Will Hall

Building 5309, constructed in 1956, has 27 family suites and 3 extended stay guest rooms. This facility has three stories plus a basement. Each family suite has 503 square feet, consisting of a living room, bedroom, kitchen, and full bath. Each guest room has 316 square feet. The building is in fair condition but does not comply with Lodging standards. The cost to make improvements and bring it up to Army Lodging standards will exceed the 50% replacement cost.

Our recommendation is to remove building 5309 from the Lodging inventory, allowing the installation to determine an alternate use for this facility. This facility will be removed from the Fort Riley Wellness Solution and Lodging Master Plan.

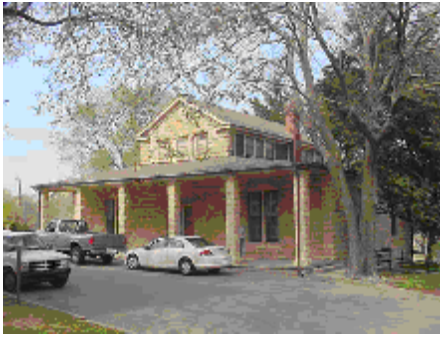
*Building 0028
Bacon Hall
Fort Riley, KS*

Condition Assessment Cost	\$240,165.00
Replacement Cost	\$432,745.00
Condition Assessment to Replacement Cost Ratio	55.50%

Because the Condition Assessment to Replacement Cost Ratio is greater than 50%, renovation of Building 28 is not recommended.
